## **Erosion Sediment Control Plan**

## Juan Tabo Hills

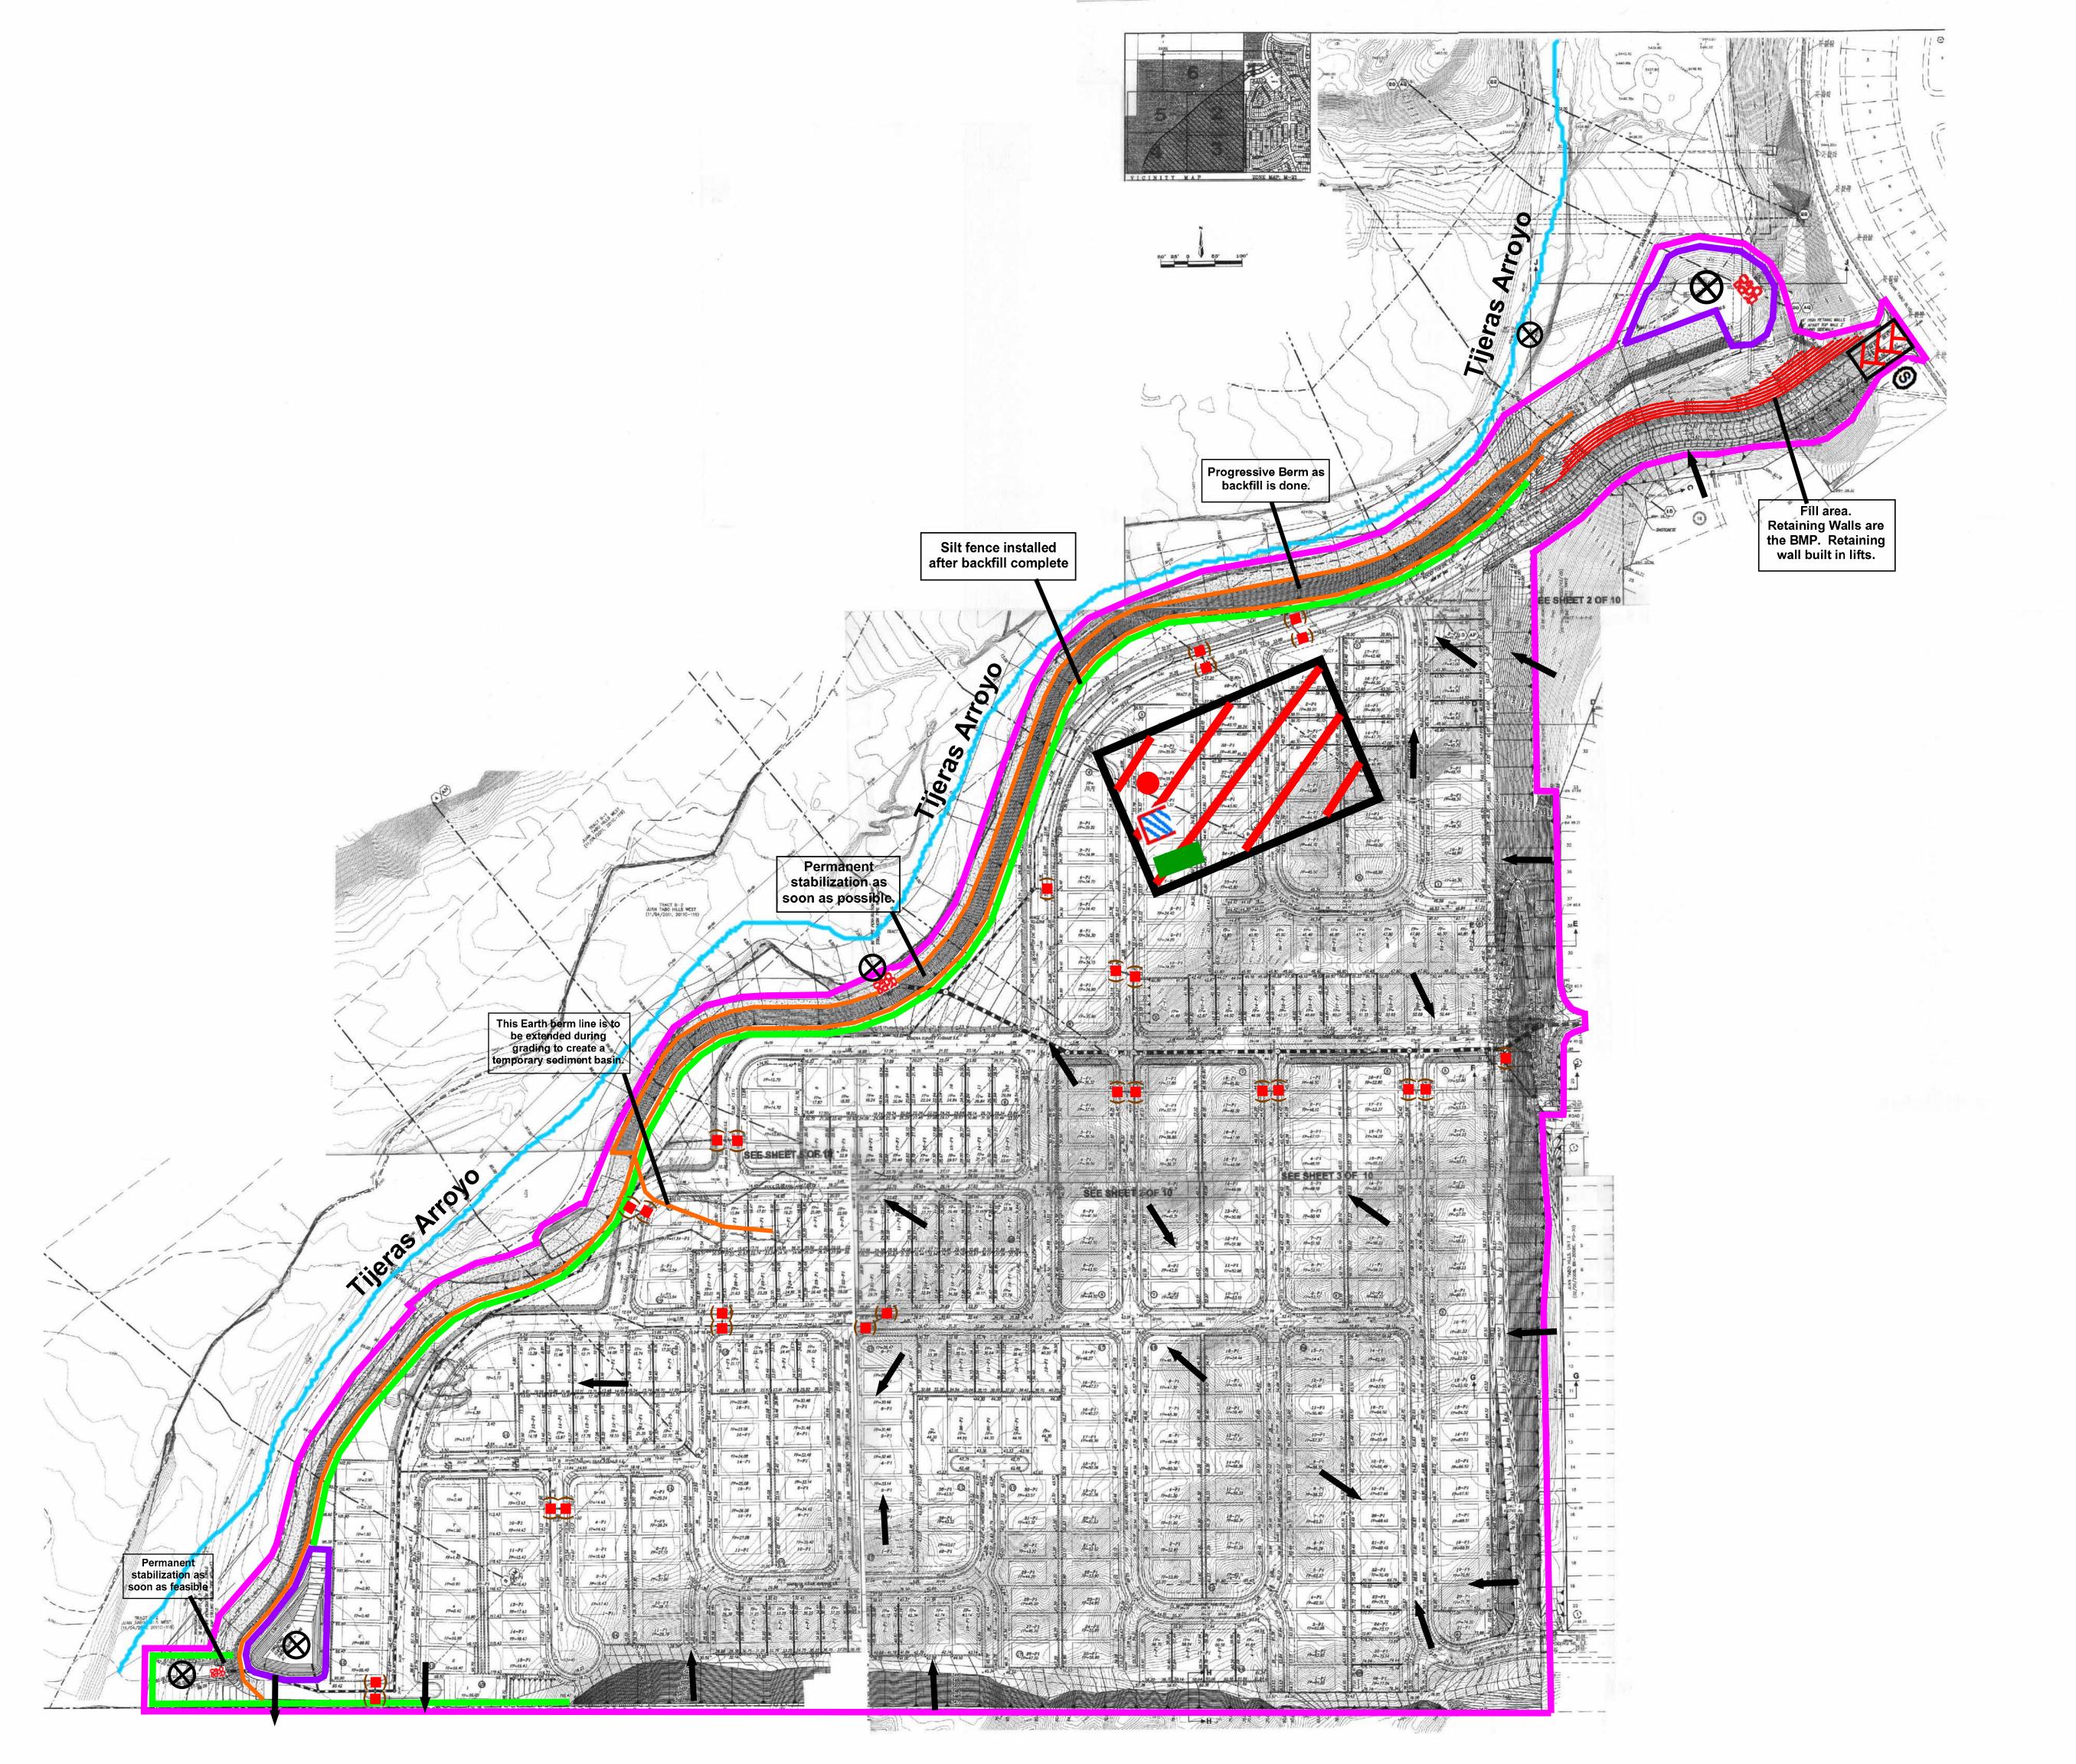
Project Perimeter & Disturbed Area

→ Pre Flow & Post Flow

Silt Fence

**Outfall**

S Posting Sign

///// Staging Area

Stabilized Construction Entrance

Trash Receptacle

Chemical Toilet

Concrete Washout

Retaining Wall

Retention Pond

Rip Rap

Inlet Protection Curb Inlet with protection

Arroyo
Earth Berm

Receiving Waters and Critical Habitat: Tijeras Arroyo is located 200 feet to the West.

Imapirments: None (Ephemeral Stream)

Grade: Before 1.0% to 6.0% depending on location After 2.0% to 3.5%
