October 6, 2017

Site: Los Diamantes Subdivision

The following violations were observed at yesterday's inspection:

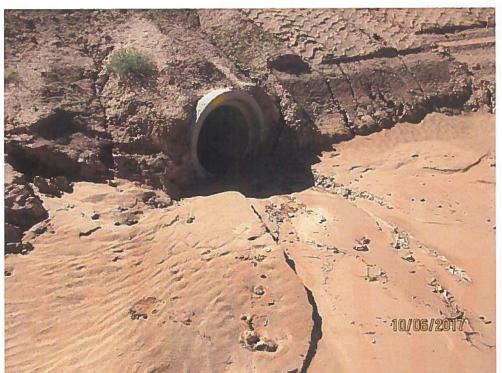
Pond outfall without a sediment BMP. Sediment entered the City's drainage system.

- 1. Provide inlet protection for the pond outfall. Protection to be a minimum of 15 inches high. A filter sock pyramid may work the best.
- 2. Remove the dirt pile in the gutter of Blake Rd and provide a sediment BMP in this location to prevent sediment from leaving the site as well as a BMP for the area where the gutter has been removed.

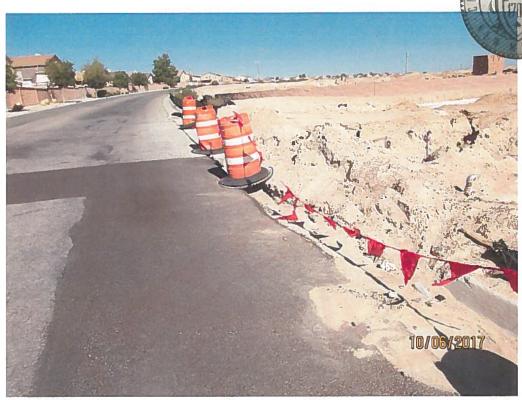
Dirt pile along Blake Rd. No sediment BMP.

- 7. Remove sediment from Blake Rd near the dirt pile.
- 8. Maintain the silt fence on Blake Rd.
- 9. Maintain the inlet protection in Blake Rd and Gibson Blvd.

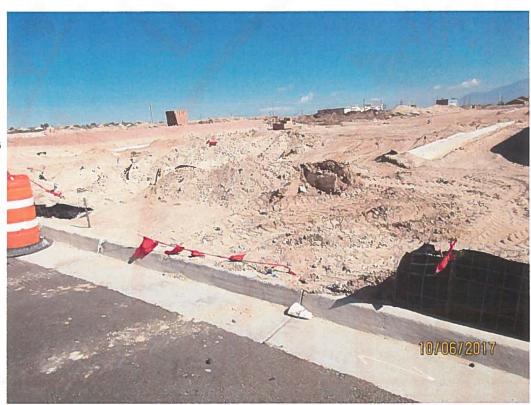
Site exit without a track-out pad. Silt fence missing.

- 3. Prevent vehicles from exiting the site onto Blake Rd or provide a track-out pad.
- 4. Remove wash-out from the pond and other locations. Provide a wash-out facility for wall builders close to work areas. An Outpak may work the best as the work areas move.

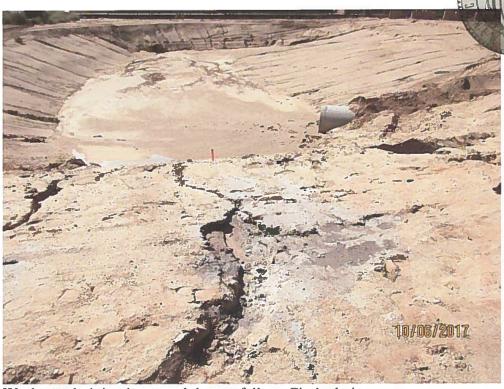
Wash-out draining into pond that outfalls to City's drainage system.

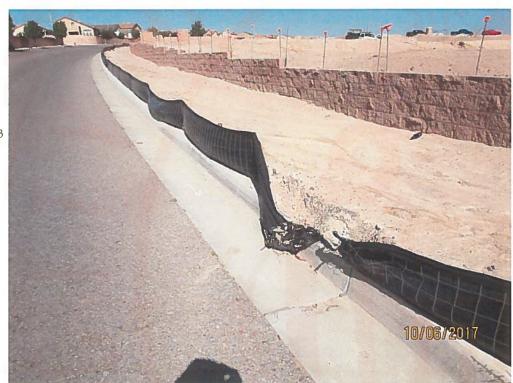
Silt fence requires maintenance.

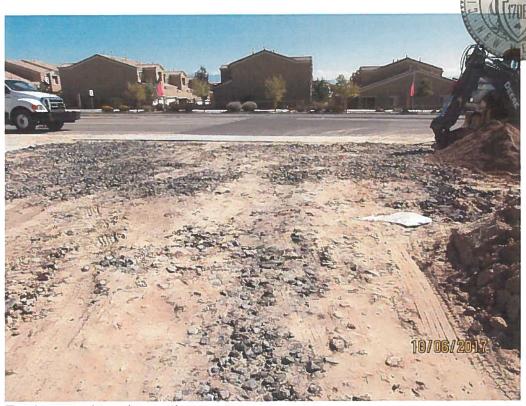
Track-out pad requires maintenance.

- 5. Maintain the track-out pad.
- 6. Remove sediment from 98<sup>th</sup> St. from the entrance area on 98<sup>th</sup> St. to approximately 100 feet south of Blake Rd.

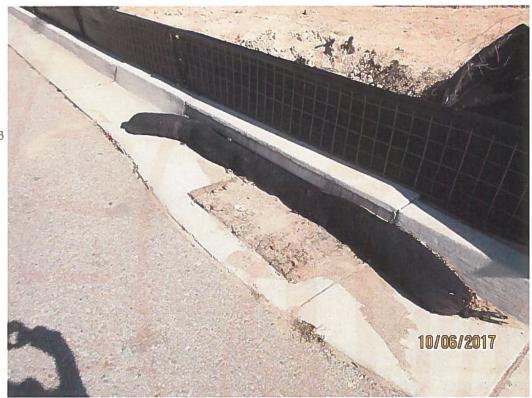
Inlet protection requires maintenance.

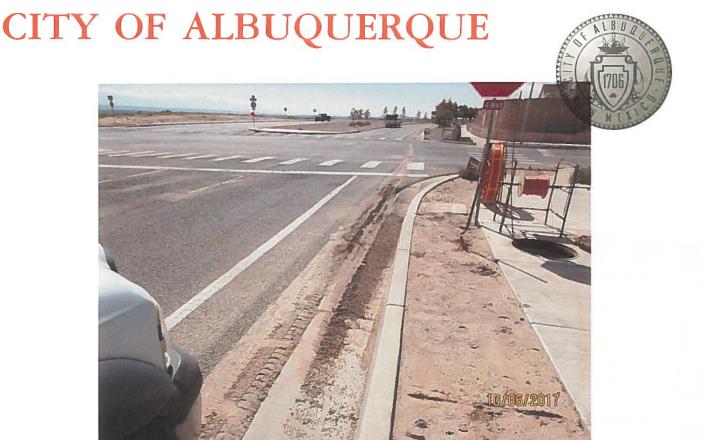
Sediment in 98th St.
