CITY OF ALBUQUERQUE

Site: Event Center at 1611 Airtech Ct SE

Re: Drainage Ordinance (14-5-6-6) Violations for Erosion and Sediment Control

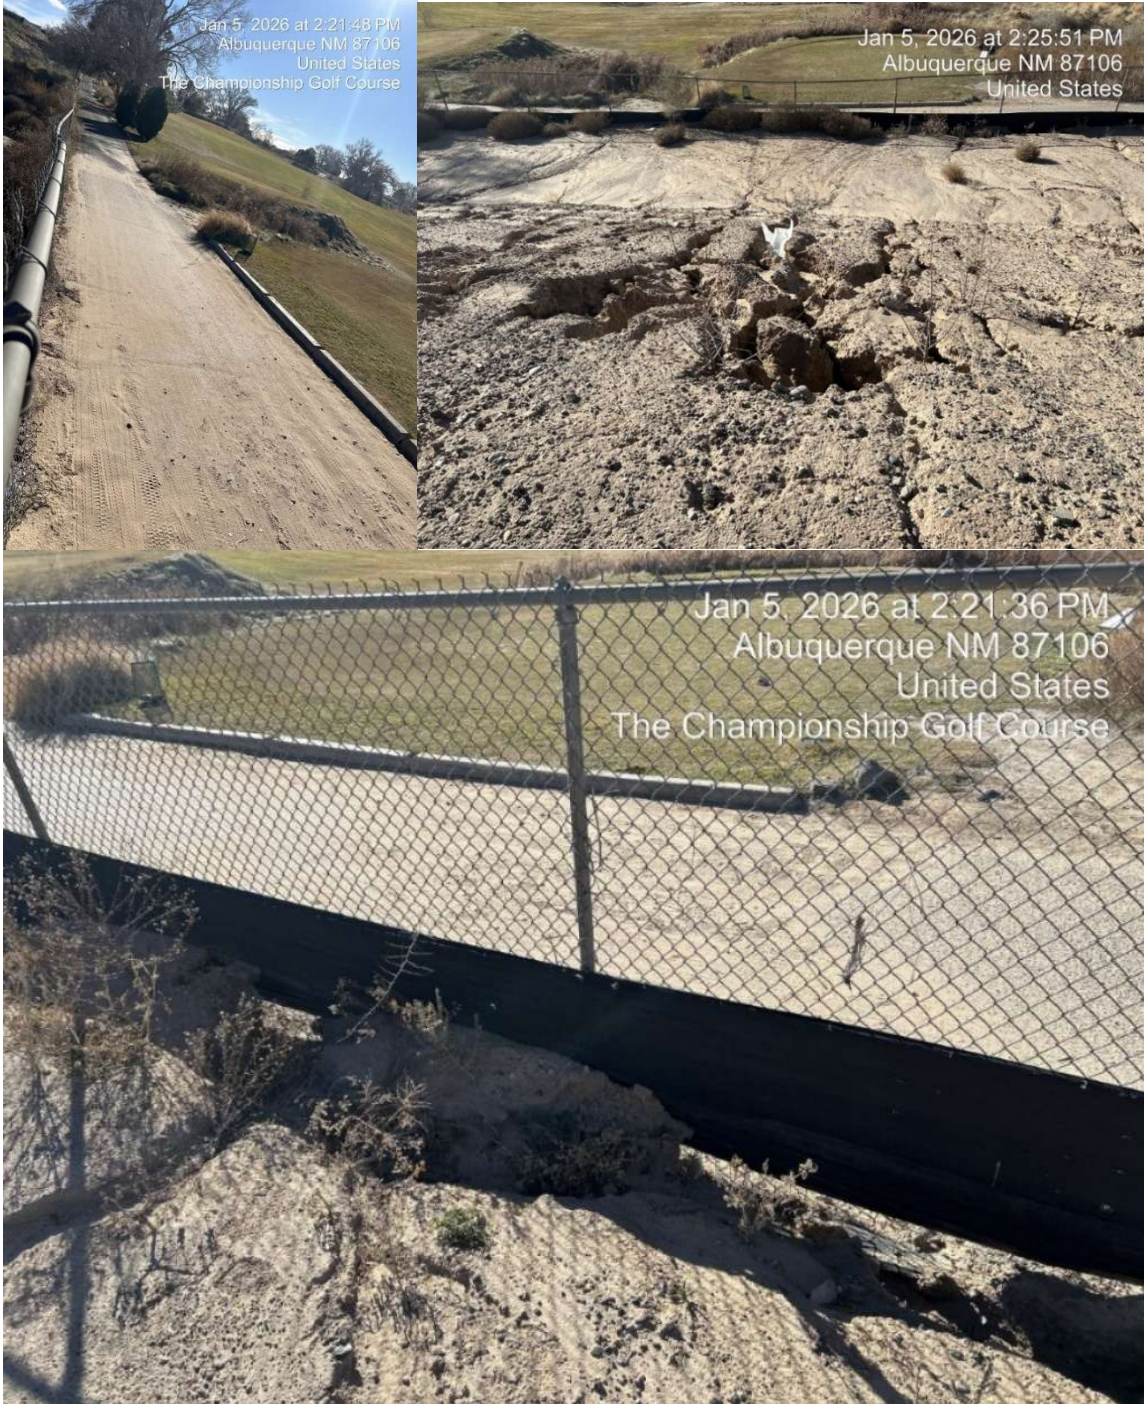
2. **BMPs** – Erosion has undercut the silt fence and is discharging dirt and sediment onto the UNM Golf Course in violation of CGP Parts 2.1.2, 2.1.4, and 2.2.3. All stormwater runoff for the 3.7-acre site discharges at the western perimeter of the property via concentrated flow at the low point of the perimeter. The perimeter silt fence is insufficient to handle the quantity of discharge for the entire site or the concentrated flows occurring from erosion.

A redesign of the stormwater controls is necessary to prevent sediment discharge from the property, such as a terraced slope or water quality pond.

2. **BMPs** – Design and install all stormwater controls in accordance with good engineering practices, including applicable design specifications per CGP Part 2.1.2. Ensure all stormwater controls are maintained and remain in effective operating condition during permit coverage and are protected from activities that would reduce their effectiveness per CGP Part 2.1.4. After a storm event, if there is evidence of stormwater circumventing or undercutting the perimeter control, extend controls and/or repair undercut areas to fix the problem per CGP Part 2.2.3.c.ii.

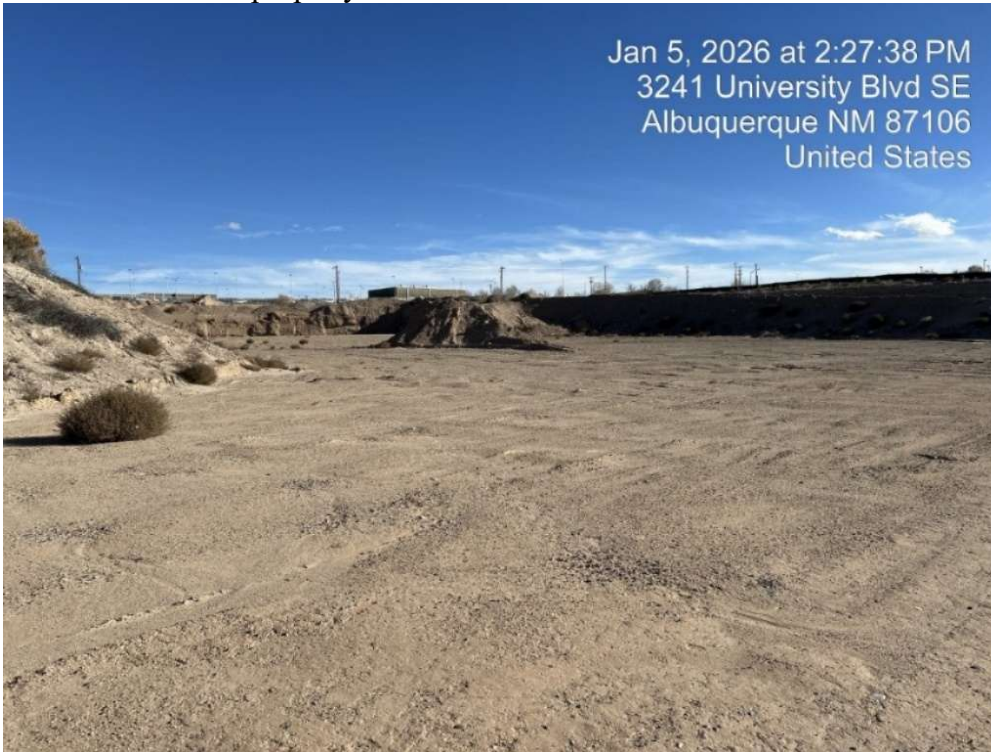
3. **Stabilization** – This site has been inactive for over 14 consecutive calendar days with disturbed and exposed soil where no stabilization measures have been installed in violation of CGP Part 2.2.14. There are extra measures needed to stabilize the steep slope on the western side of the property.

3. **Stabilization** – Initiate the installation of stabilization measures immediately in any areas of exposed soil where construction activities have permanently ceased or will be temporarily inactive for 14 or more calendar days per CGP Part 2.2.14. You must complete the installation of stabilization measures as soon as practicable, but no later than 14 calendar days. According to City Specification 1013, slopes between 2:1 and 3:1 must be stabilized using aggregate mulch with a size of 2” – 8” rock in a layer one rock deep.
